Fuel exhaustion and collision with terrain involving McDonnell Douglas Corporation 369D, VH-PLY

36km NW Hawker, South Australia | 17 July 2016

ATSB Transport Safety Report Aviation Occurrence Investigation AO-2016-078 Final – 2 August 2018 Cover photo: Aircraft operator

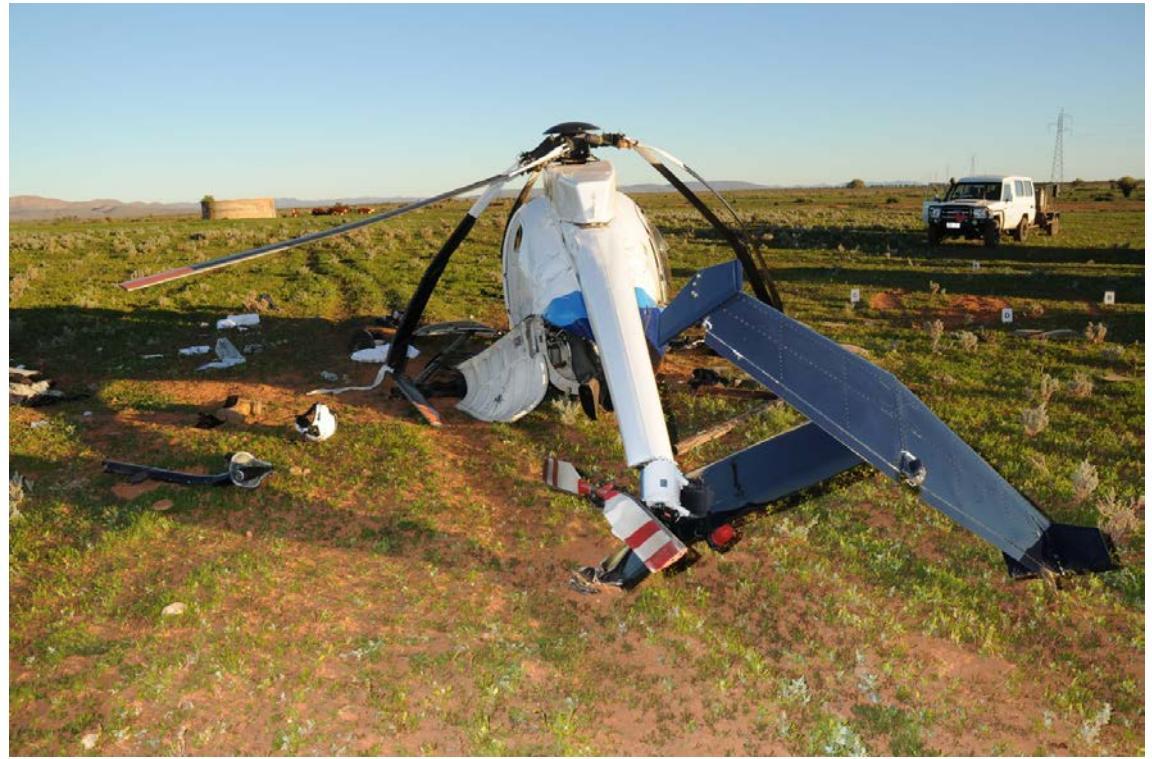
Figure 1: VH-PLY accident site

On 17 July 2016, at about 1039 Central Standard Time,¹ a McDonnell Douglas Corporation 369D helicopter, registered VH-PLY, collided with terrain after experiencing fuel exhaustion while performing powerline inspections 36 km north-west of Hawker, South Australia (Figure 1). There were three crew on board the helicopter. One pilot in the front left seat, one line-worker (data recorder) in the front right seat and one line-worker (inspector) in the rear left seat. The three crew members were seriously injured and the helicopter was substantially damaged.

- no post-impact fire
- no smell of fuel in the wreckage
- no evidence of entrapped fuel within the wreckage
- no usable fuel in the main tank fuel bladder
- main tank bladder was intact and the only identifiable puncture mark was at the top of the bladder and considered to be the result of the impact
- no residual fuel in the fuselage cavity housing the fuel bladder
- minimal fuel found in the airframe and engine fuel filter bowls
- auxiliary fuel tank was empty
- the fuel indicator, showing low fuel level, and fuel transfer systems were found to be serviceable.

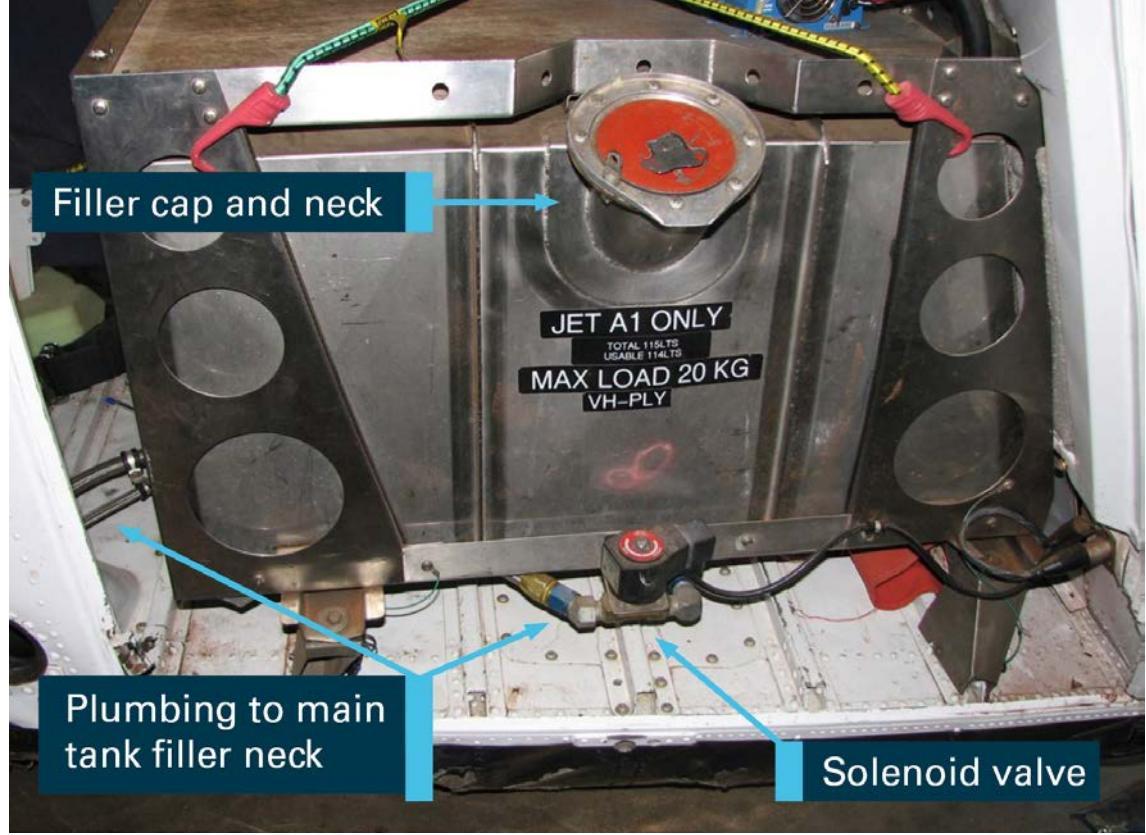
Figure 2: Auxiliary fuel tank fitted to VH-PLY

The auxiliary fuel tank was manufactured from stainless steel. It had a volume of 125 L, but a specified capacity of 115 L when filled to the bottom of the filler neck. The tank was located in the rear right side of the cabin. Fuel transfer was controlled by the pilot operating the solenoid valve switch, located on the instrument panel, marked 'AUX. FUEL TRANSFER'. A green indicating light, located next to the fuel transfer switch would illuminate when the switch was selected to the transfer position. When selected, fuel would gravity drain from the auxiliary tank to the main tank. The main fuel tank provided the fuel supply to the engine.

The auxiliary fuel tank system did not include a fuel quantity indicator or sight glass or dip stick to check the fuel quantity. Only the main fuel tank system incorporated a fuel quantity indicator. The pilot reported that the auxiliary fuel tank quantity would normally be visually checked by removing the fuel cap before flight, but could not explain how the quantity was verified by a visual check if the tank was filled to less than full.

The operator immediately removed all auxiliary fuel tanks from their helicopter fleet and restricted their powerline patrols and inspection flights to main fuel tank fuel only. They developed a corrective actions plan, which included modifications to the auxiliary fuel tank system; permanent installation of a remote warning device; and amended their operations manual to include prescriptive fuel check instructions.

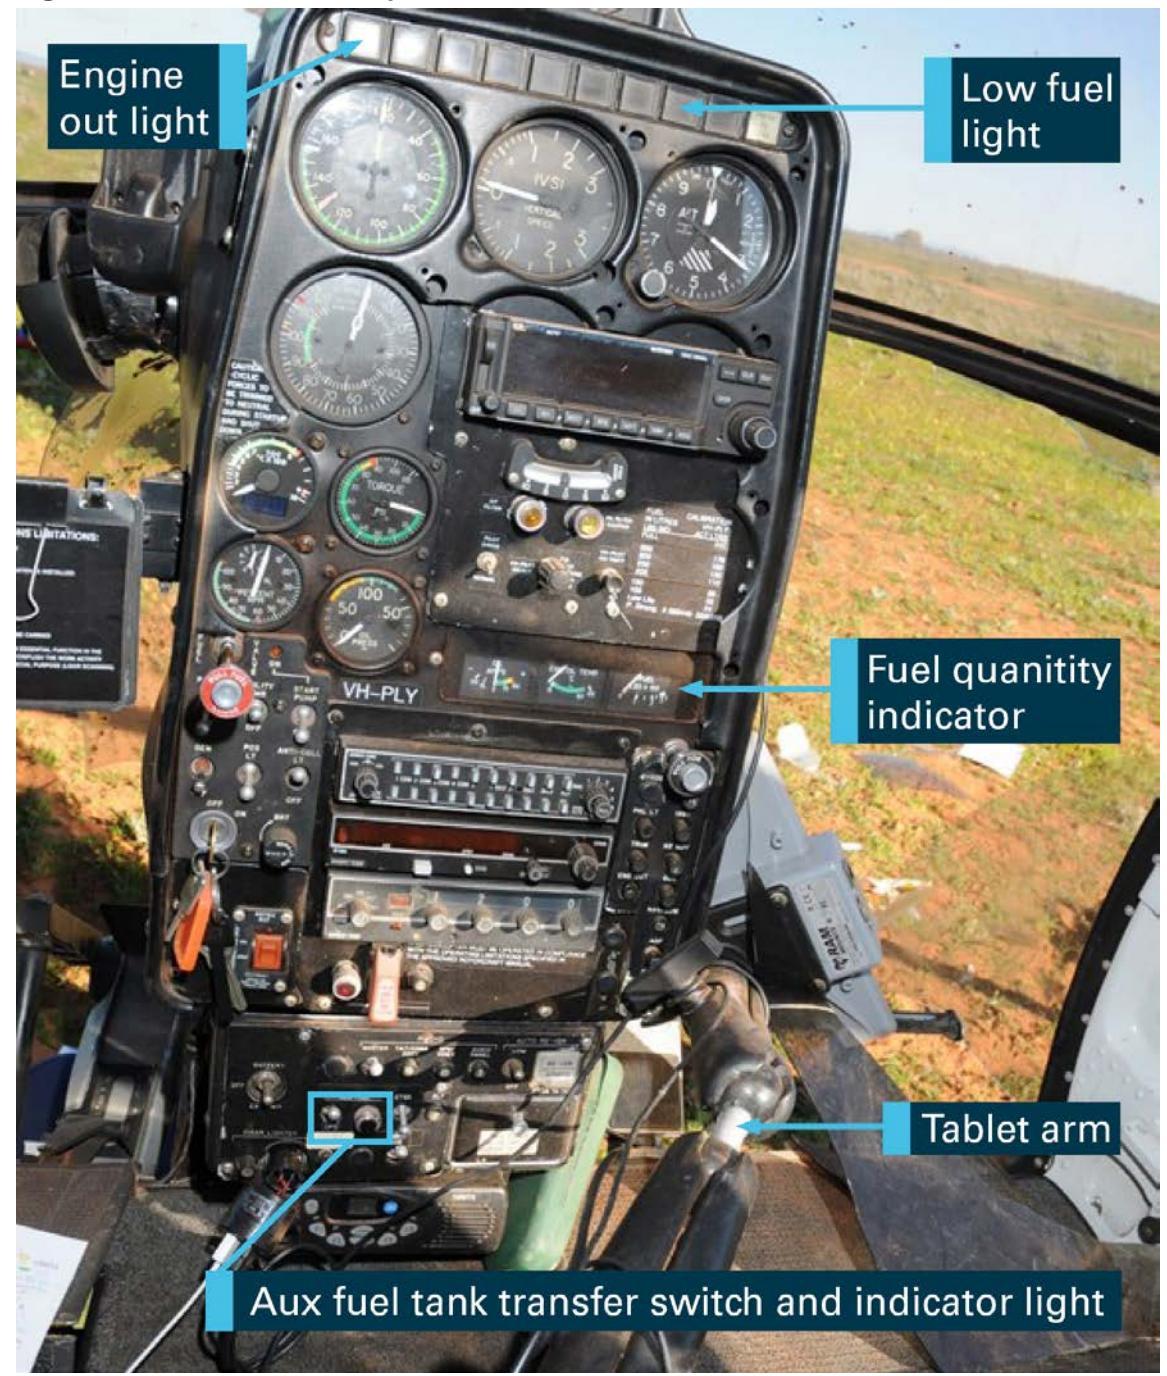
Figure 3: VH-PLY instrument panel

The helicopter was manufactured to be flown by the pilot in command from the left seat instead of the normal right seat helicopter pilot position. The primary flight instruments were located on the left side of the centrally mounted instrument panel and the secondary instruments, including the fuel quantity indicator and low fuel level caution light, on the right side (Figure 3).

It was not determined if the front right seat crew member had positioned his tablet-mount in a position which would have obstructed his view of the fuel quantity indicator or low fuel level caution light. At the time of the accident, the right seat crew member was conducting data recorder tasks on his computer with his tablet mount extended. During the investigation, the ATSB adjusted the right seat tablet and found that it could be positioned in a way that would obscure the fuel quantity indicator or low fuel level caution light.

The operator reported the low fuel level caution light would activate intermittently at about 30 L fuel remaining and remain on constantly at about 25 L fuel remaining; about 15 minutes of flight time. The sun was in the range of the twelve o'clock position at a low angle leading up to the accident.¹⁸ In this position, the sun would have been in the same general field of view as the instrument panel lights for the pilot in the left seat, who was wearing a helmet with dark visor.

The low fuel level caution light was set to illuminate with about 15 minutes of fuel remaining and found to be serviceable following the accident. However, it was possible the position and luminance of the sun reduced the pilot's visual sensitivity to the low fuel level caution light. The operator's remote warning device, used to alert the pilot to the activation of a caution or warning light on the master caution/warning panel, was not fitted. Leading up to the accident sequence, the pilot's hover reference was the powerline on the left side of the helicopter and the front right seat crew member was performing his data recorder duties. Therefore, it was likely that the low fuel level caution light was not detected because neither of the front seat crew members were scanning the instrument panel leading up to the accident.

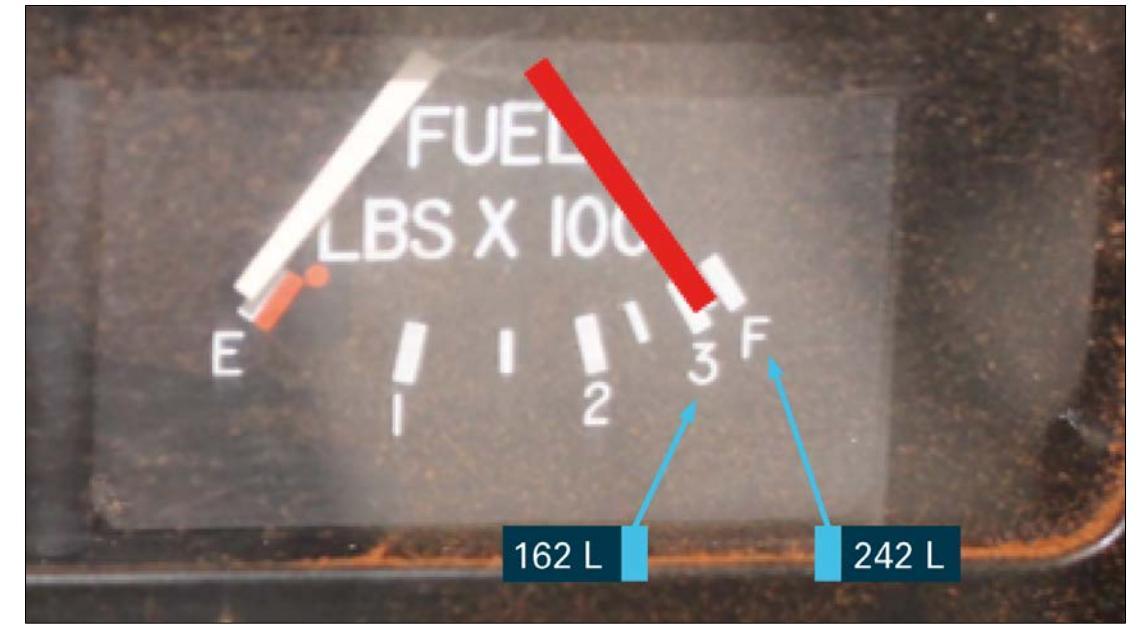
Figure 4: VH-PLY main fuel tank quantity indicator (graduated in pounds x 100)

The helicopter's main fuel tank quantity indicator was a nonlinear indicator, which was more sensitive at lower fuel levels than at higher fuel levels (Figure 4). At the previous routine 100 hourly maintenance inspection, the fuel tank quantity indicator sensor was replaced and a fuel

calibration performed. On the fuel quantity indicator, the three hundred pounds' marker (3) was the equivalent of 162 L and the full marker (F) was 242 L.

The pilot reported he was told the helicopter had been refuelled before flight. He was also observed by the right seat crew member performing his normal pre-start instrument scan and he reported he thought the fuel quantity indicator indicated full. The flight log from the previous day was closed with 170 L of fuel remaining after a 2-hour flight and the pilot transferred the auxiliary fuel tank contents into the main fuel tank during the flight.²⁰ In this scenario, the fuel quantity indicator would have indicated close to the red line in Figure 4.

Before starting the engine, the pilot was observed conducting his normal instrument scan; however, the fuel quantity indicator had a nonlinear scale, which indicated close to the full (242 L) level mark at 170 L. The expectation that the tanks were full as indicated by the ground support person meant that when he scanned the flight instruments before flight, he would have been expecting to see a full indication. Combined with the nonlinear scale, this would have made it easy to misperceive the main tank as full. In turn, perceiving the main tank as full would have reinforced his belief that the auxiliary fuel tank (which had no fuel gauge) was also full. The helicopter subsequently departed with about 170 L of fuel on board, but the pilot believed it was carrying about 350 L.
